Preliminary Sources Study Report (PSSR)

Bus Connects Core Bus Corridor 1: Clongriffin to City
Centre

National Transport Authority

5 November 2019

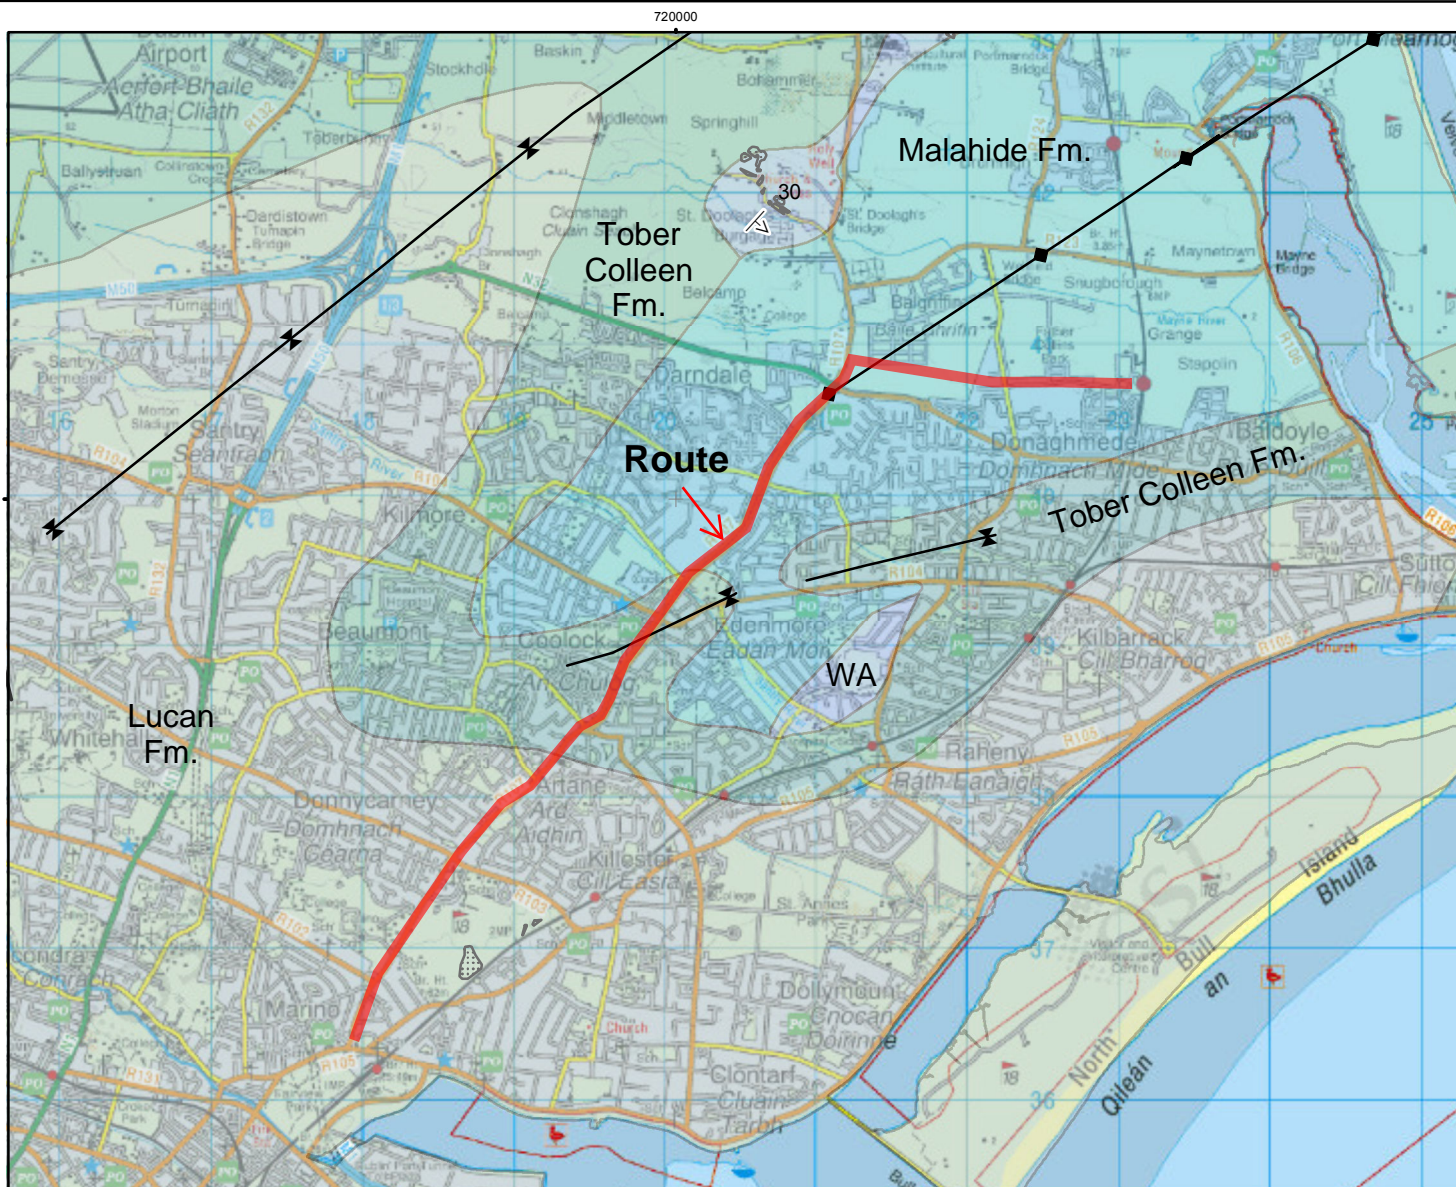
- Strike and dip of bedding, right way up
- Bedrock Outcrops 100 ITM 2018
- Anticlinal Axis
- Fault
- Synclinal Axis
- Lucan Formation
- Malahide Formation
- Tober Colleen Formation
- Waulsortian Limestones

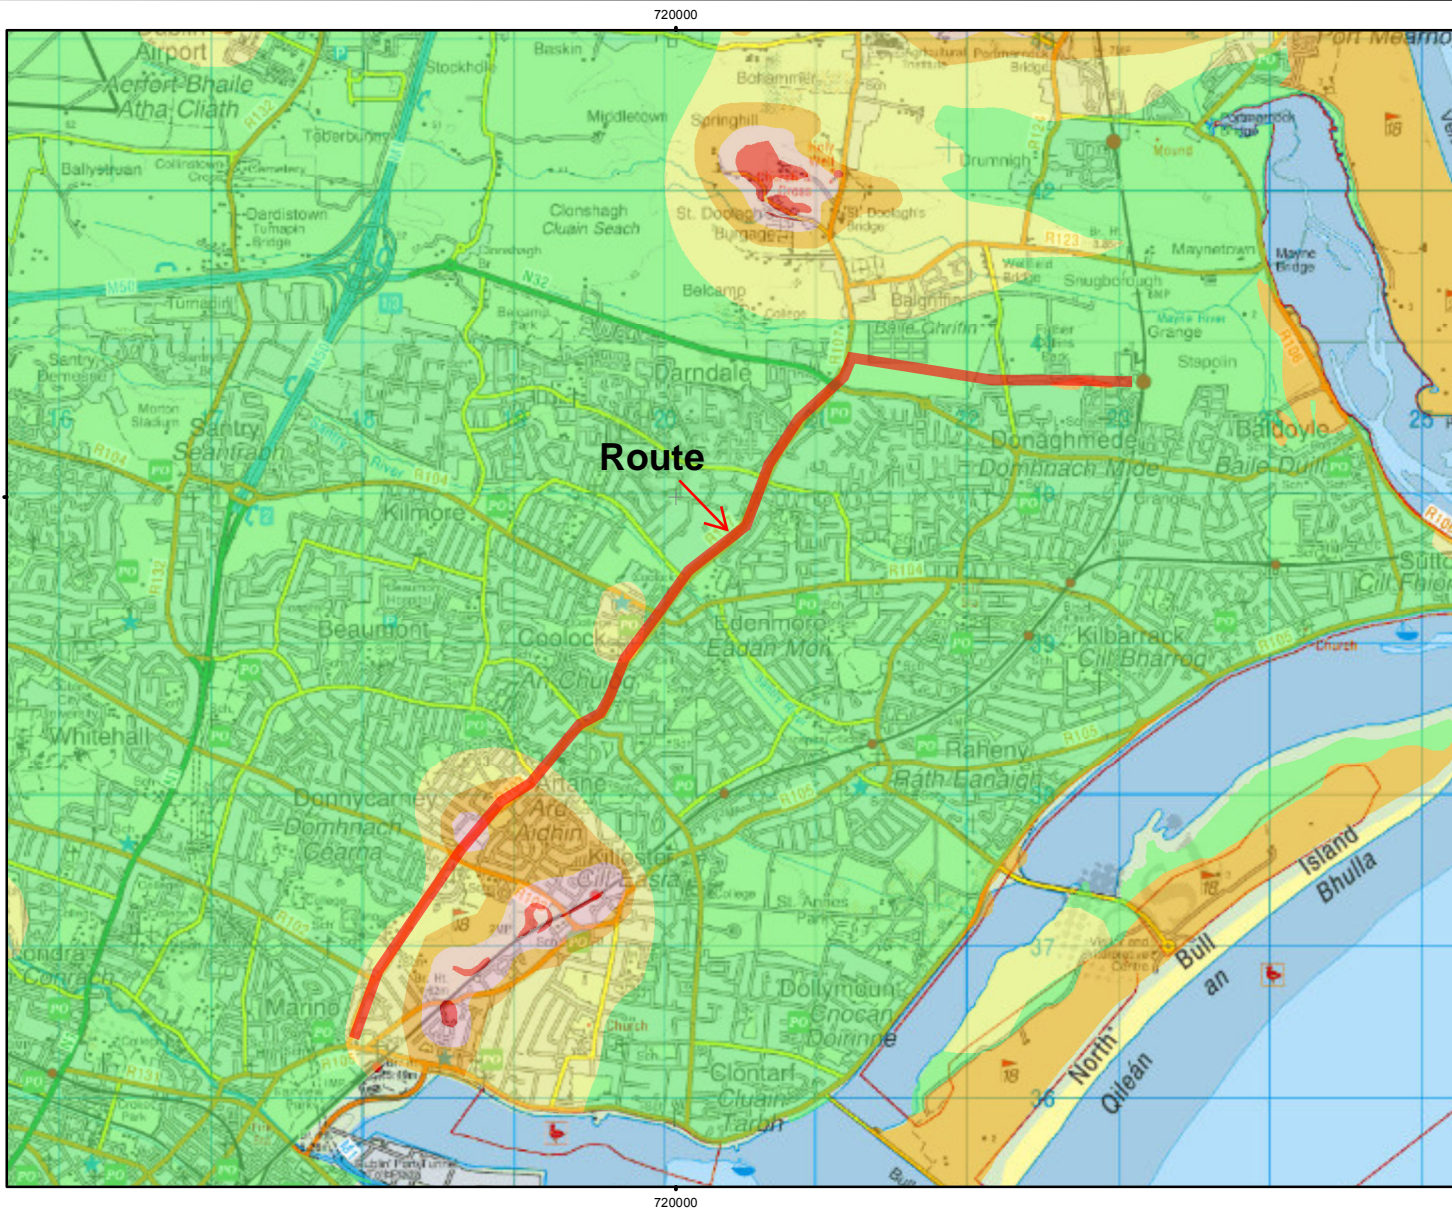
- Rock at or near Surface or Karst
- Extreme
- High
- Moderate
- Low

However, the southern 2.3km of the scheme lies within an area of "Moderate" to "Extreme" groundwater vulnerability. It should be noted that rock is recorded at or near surface to the east of the route at this location.
