Appendix M
Road Safety Audits

Clongriffin to City Centre CBC

City Centre to Kimmage CBC

Road Safety Audit Stage 1

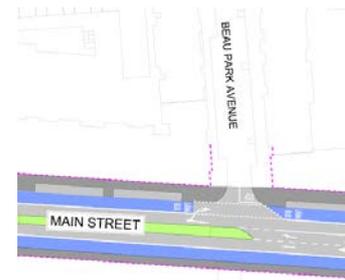
There is inconsistency in the provision of cycle facilities through the project. This could lead to confusion for cyclists putting them in conflict with vehicular traffic.

Figure 1 Example of Bus lane with no alternative cycle facilities

The design team shall review all locations and ensure there are adequate cycle facilities/ alternative routes provided along the full route of the CBC.

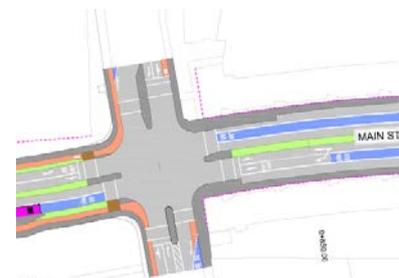
Figure 3 Example of bus lane abruptly beginning

The design team shall review the beginning of all bus lanes to ensure there is an appropriate taper at the beginning of all bus lanes after all side road junctions.

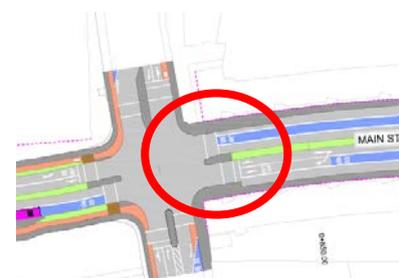
Figure 4 Example of lack of cycle facilities at a major junction

The design team shall review all junctions to ensure cycle facilities are provided in accordance with National Cycle Manual.

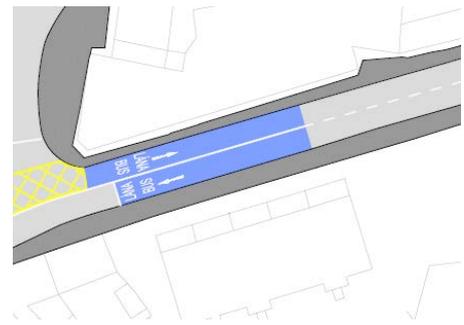
There are a number of bus gates and Cul-De-Sac's proposed where local traffic will be required to perform a turn about. There are no provisions for turning heads to be provided in these locations. This could result in large vehicles such as refuse trucks having to reverse long distances and into other streets potentially putting all other road users at risk of collisions by such vehicles.

Figure 6 Example of bus gate with no turnabout facilities

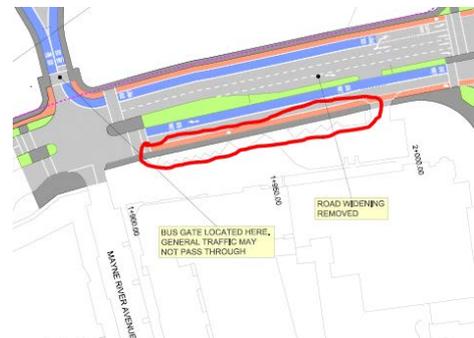
There are a number of areas where existing parking facilities are to be removed in front of commercial and residential premises. If no alternative parking is available vehicles may park on the proposed cycle track forcing cyclists onto the road and into potential conflict with vehicular traffic.

Figure 7 Example location where parking is being removed

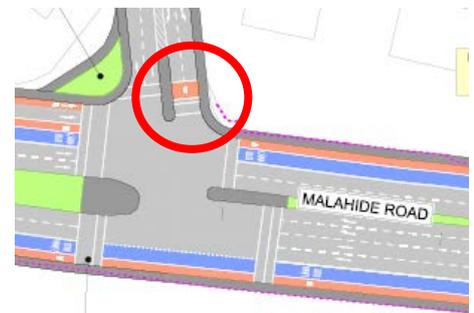
There are some junctions where advance stopping lines (ASLs) are used to allow cyclists to proceed ahead of traffic. At some of these junctions there are no feeder cycle lanes provided as required by the National Cycle Manual. This could potentially cause side swipe collisions between cyclists and vehicular traffic.

Figure 8 Example of ASL with no feeder cycle lane

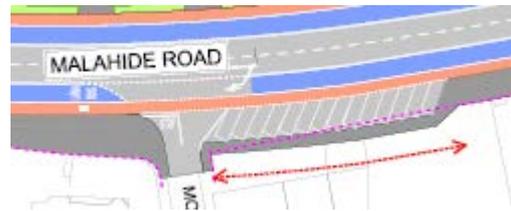
At Malahide Road, South of Mornington Grove (Sheet 14 of 28) there are existing parking spaces which are near perpendicular to the road and cycle track. There is a risk that vehicles reversing out of these spaces will not see an oncoming cyclist or other traffic approaching, and reversing into their path.

Figure 10 Perpendicular parking on Malahide Road

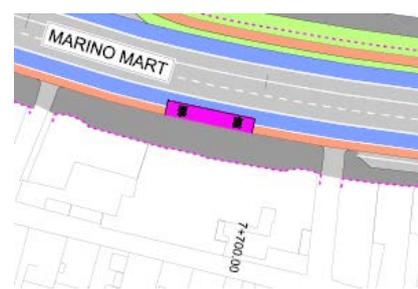
Figure 15 Example of bus stop in conflict with cycle track

The designers shall review all bus stops which are in conflict with a cycle track and ensure there are adequate facilities provided for cyclist around bus stops.

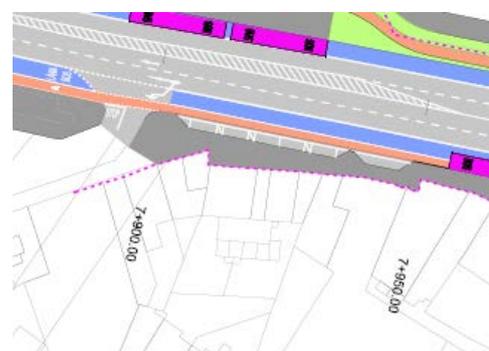
There are a number of areas where the cycle track is to run between parallel parking and the carriageway. It is unclear if there is a buffer zone is provided between the parking area and the cycle track. The lack of a buffer zone could cause side swipe collisions between cyclist and opening of car doors within the parking areas.

Figure 16 Example of cycle track between parking area and carriageway.

The design team shall ensure as a minimum there is a buffer zone between parked vehicles and cyclists. Ideally the cycle track should go between the footway and the parking area to reduce the potential conflict between vehicular traffic and cyclists.

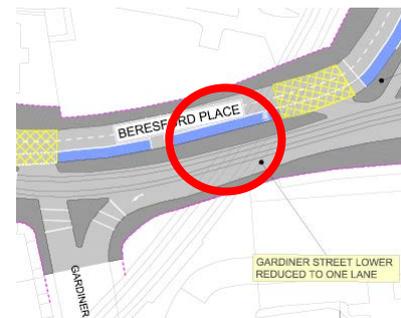
Figure 17 Uncontrolled crossing on Beresford Place

The design team shall review this crossing and provide adequate crossing facilities for pedestrians.

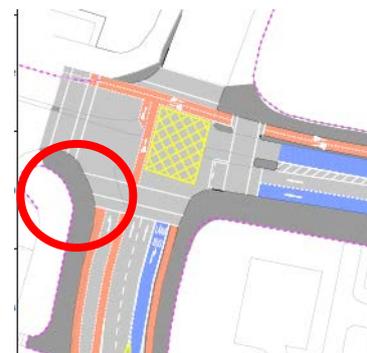
Figure 19 Example where left slip lane removed and consideration required for signal heads

The design team shall ensure there are adequate signals placed in a conspicuous location at all junctions

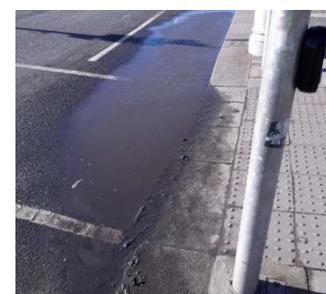
It was noted during the site visit that there was inadequate drainage facilities at some crossings. This could lead to pedestrian slipping on surface water or meandering away from the designated crossing point to avoid puddles and leading to conflict with traffic.

Figure 20 Example of existing drainage issues at existing crossing on Custom House Quay

The design team shall ensure there are adequate drainage facilities provided at all crossing locations. The design team shall ensure there are no low points or drainage gullies located within the crossing locations.

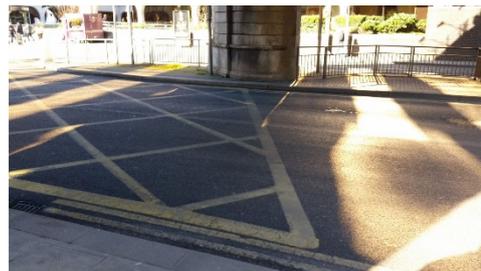
There is a narrow cross section under the rail bridge on Beresford Place where currently there are 2 lanes of traffic. It is noted that the alignment at this location is curved and required wider lanes for swept paths of large vehicles such as buses and goods vehicles. It is proposed to have 3 lanes of traffic in this location which may require narrow lanes. This could lead to side swipe collisions between the lanes of traffic. There are also additional locations with similar problems on Memorial Road and Amiens Street

Figure 21 Narrow cross section on Beresford Place

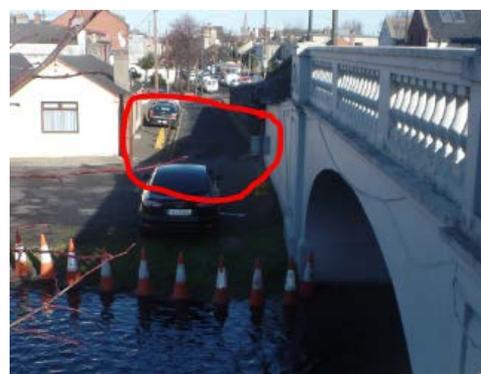
It is proposed to provide a cantilevered extension over the Grand Canal Bridge (Sheet 3 of 19). The reduction in horizontal and vertical clearance of the proposed structure from the access road could result in an increased risk of collisions between vehicles enter the builders yard and the extended structure.

Figure 22 Pinch point between existing building and structure

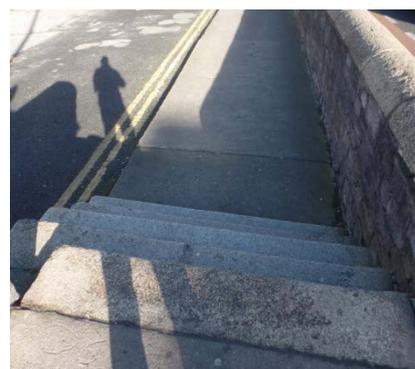
There are currently steps on Clanbrassil Street Upper which will impact on the movements of mobility impaired. These could lead to an increased risk of falls by mobility impaired pedestrians.

Figure 23 Steps located on Clanbrassil Street

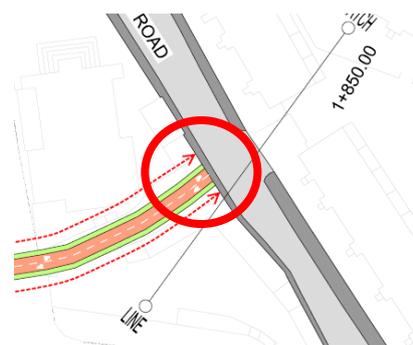
Figure 24 Lack of Visibility to cycle track

The design team shall review the location and ensure there is sufficient visibility between traffic on Mount Argus Road and cyclists using the proposed cycle track.

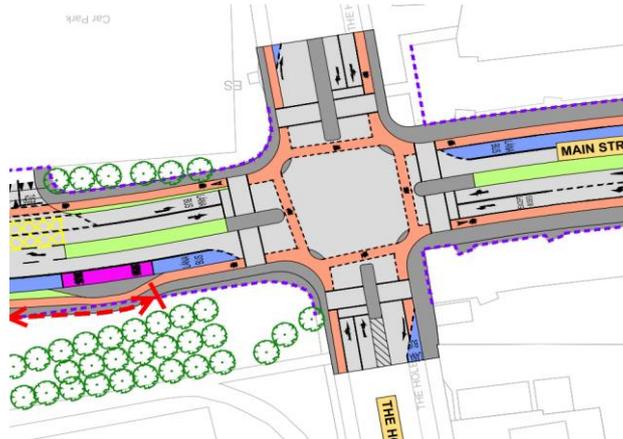
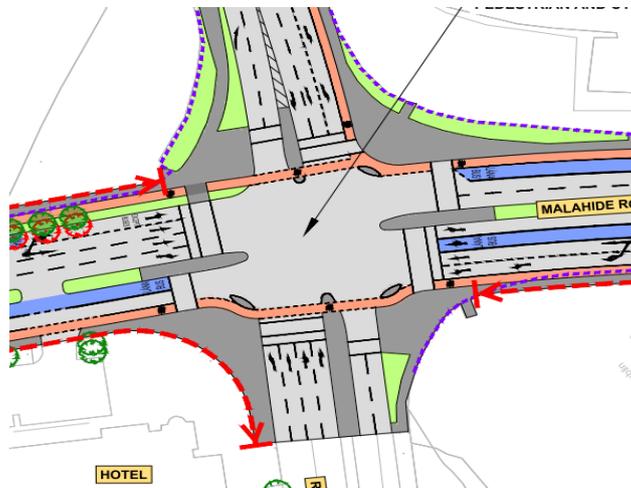
No detail has been provided in relation to the tactile paving to be provided at any of the crossing points / junctions throughout the scheme. Lack of appropriate tactile paving may result in confusion for vision impaired pedestrians. Failure to provide a footpath across the junctions/entrances would give motorists priority and therefore increase the risk of collisions with pedestrians.

Figure 4.1: Crossing Points along Main Street / The Hole in the Wall

Figure 4.2: Crossing Points along Malahide Road / R139 Junction

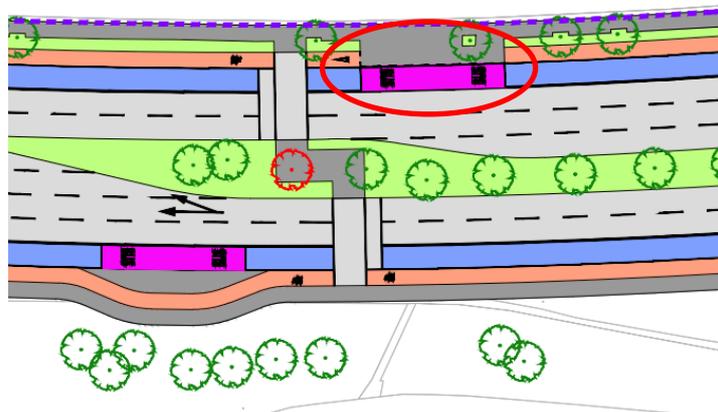
Figure 4.3: Bus Stop on Malahide Road

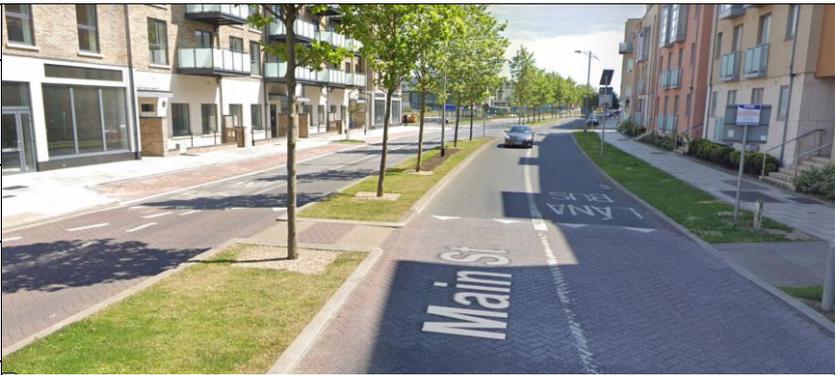
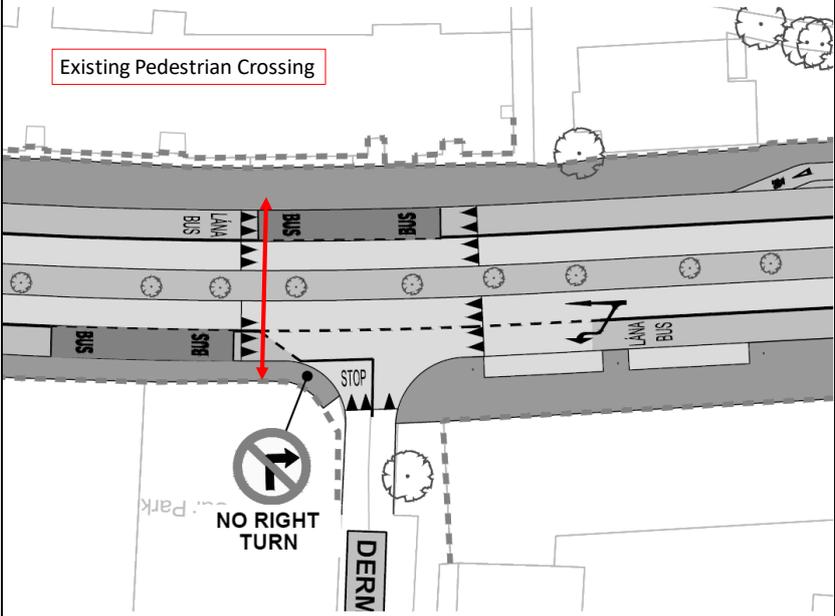
Figure 4.4: Existing Pedestrian Crossing on Main Street

Figure 4.5: Pedestrian Crossing not indicated in the design

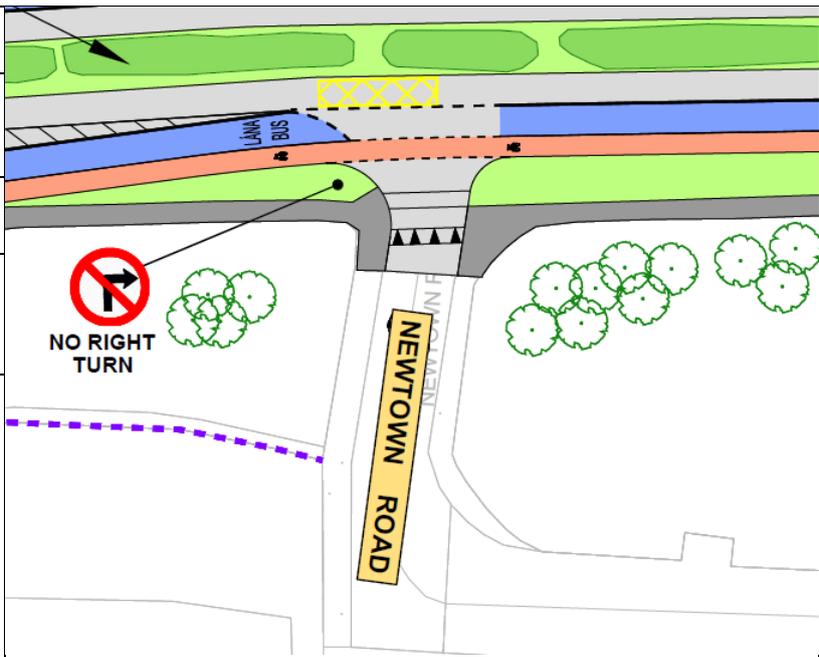
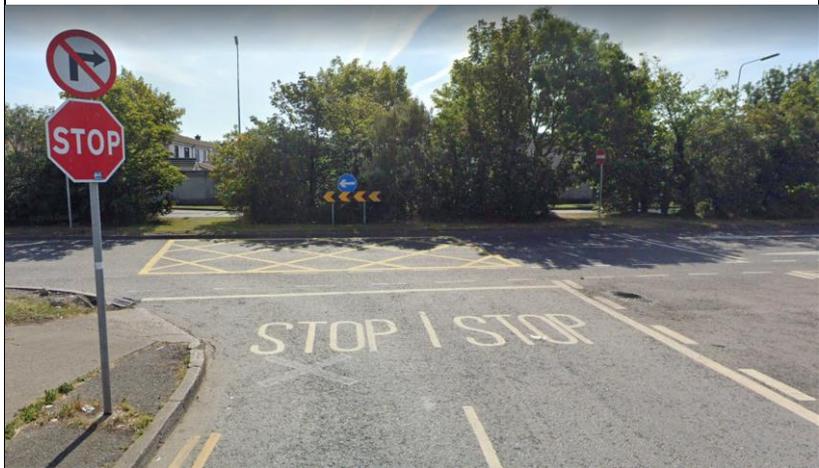
Figure 4.10: Proposed Access to Malahide Road

Figure 4.11: Existing Access to Malahide Road

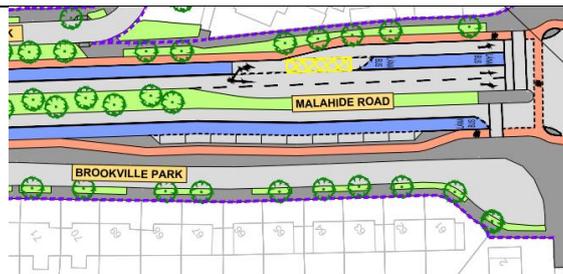
Figure 4.14: Proposed Parallel Car Parking Spaces

4.3.9 Problem	
Location:	Malahide Road (Northbound)
Drawing:	Sheet 11 of 21 & Sheet 12 of 21
Summary:	Car parking spaces are provided along bus lanes without a buffer

A buffer should be provided between the bus lane and the parallel car parking spaces.

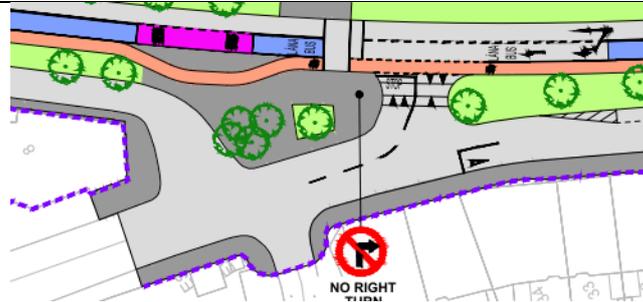
Figure 4.16: Proposed Arrangement

4.3.10 Problem	
Location:	Coolock Village (Brookville Park Road)
Drawing:	Sheet 12 of 21
Summary:	Lack of pedestrian crossing locations

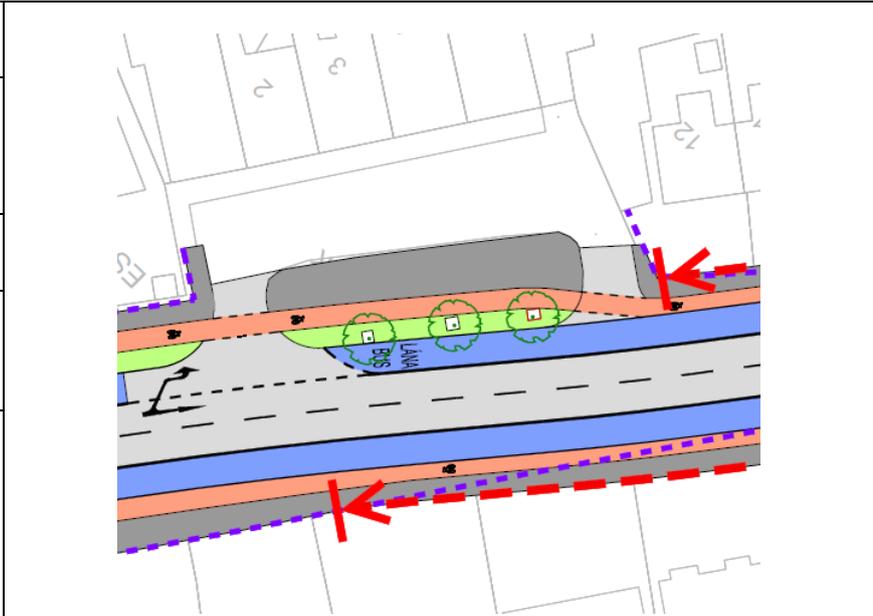
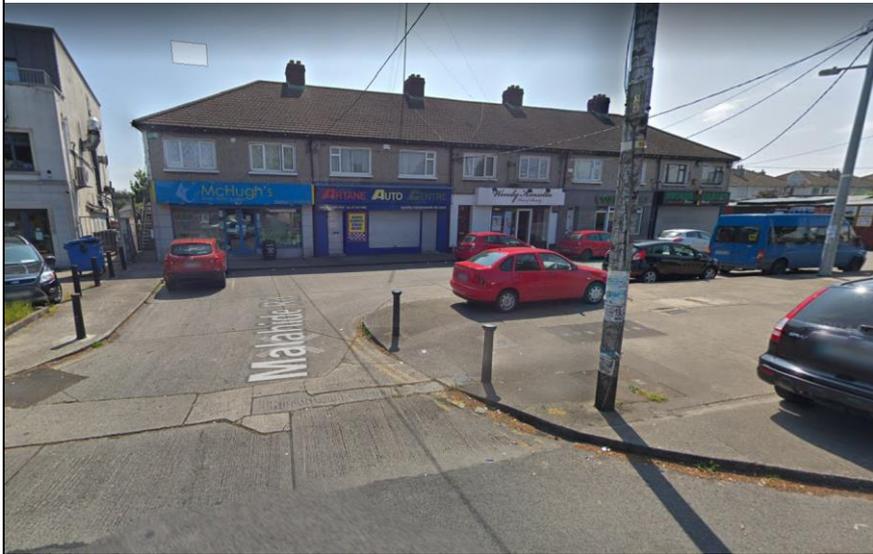
Figure 4.18: Access to McHugh's off-licence / Artane Auto Centre

Figure 4.19: Existing Access Arrangement

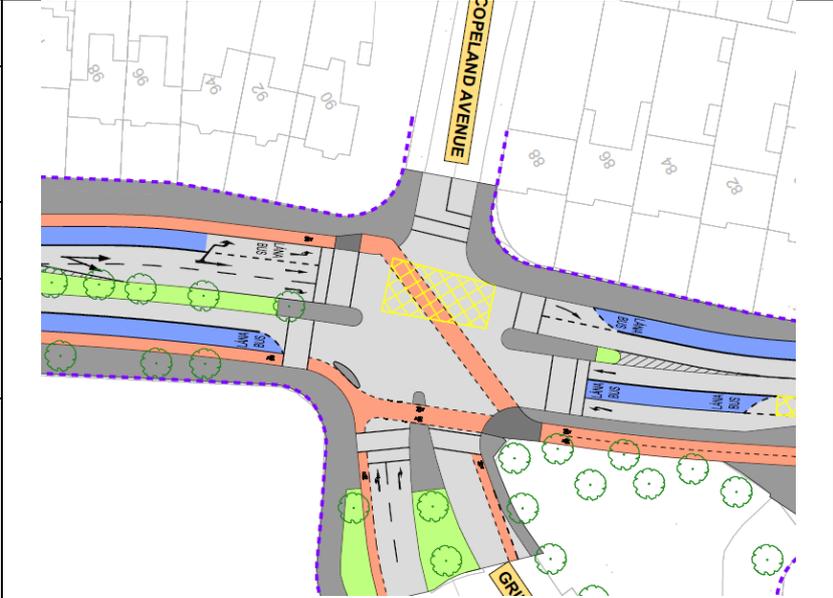
<p style="text-align: center;">Figure 4.22: Malahide Road / Copeland Avenue / Griffith Avenue</p>
Location:	Malahide Road / Copeland Avenue / Griffith Avenue Junction	
Drawing:	Sheet 19 of 21	
Summary:	Cycle Lane Staging	
Description:		<p>No staging information has been provided, but the current layout would indicate that if cyclists are permitted to proceed at the same time as traffic on the southbound traffic lanes, it could result in collisions with vehicles as they attempt to turn right across the road carriageway.</p>
Recommendation:		<p>Controlled signal facilities should be provided for cyclists wishing to cross the road carriageway. The cycle staging should be separated from the traffic movements.</p>

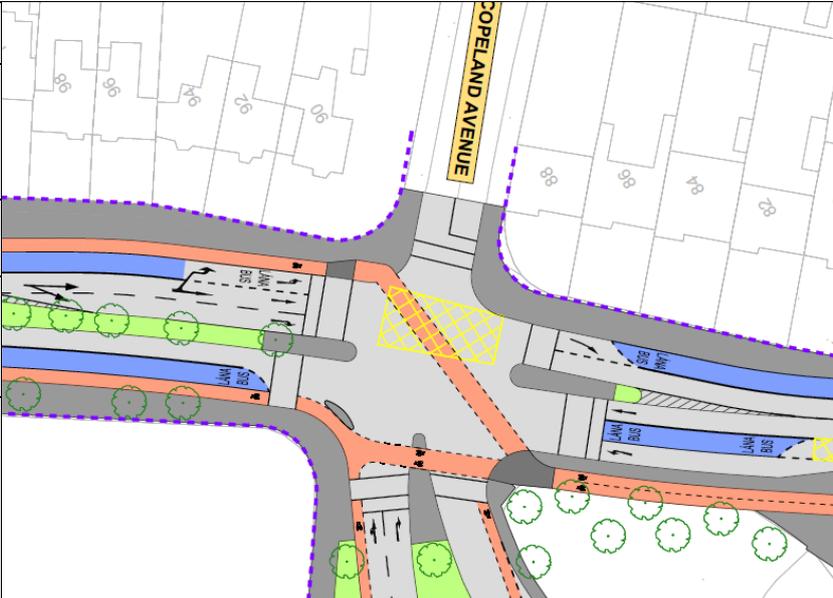
<p style="text-align: center;">Figure 4.23: Malahide Road / Tesco Junction</p>
Location:	Malahide Road / Copeland Avenue / Griffith Avenue Junction	
Drawing:	Sheet 19 of 21	
Summary:	Cycle Lane on Griffith Avenue appears too narrow	
Description:		<p>The cycle lanes provided along the Griffith Avenue on both sides of the carriageway appears to narrow on approach to this junction. This could result in inadequate cycle lanes being provided which may lead to cyclist-vehicle collisions at this junction.</p>
Recommendation:		<p>Appropriately sized cycle lanes are to be provided at this location, in accordance with the National Cycle Manual.</p>

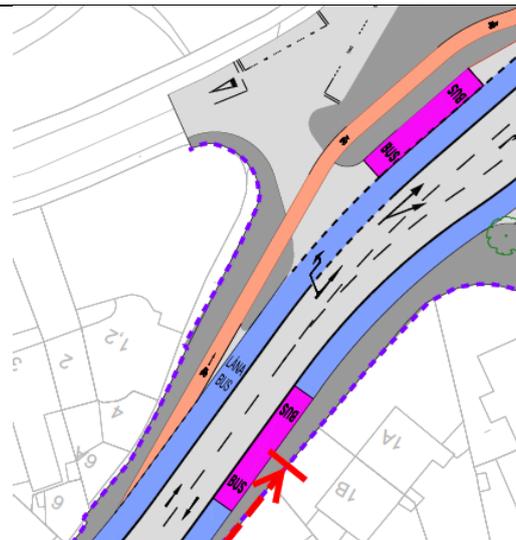
Figure 4.29: Access to Marino Crescent

4.3.19 Problem	
Location:	Malahide Road
Drawing:	Sheet 21 of 21
Summary:	Angle of turning cars across the proposed cycle lane

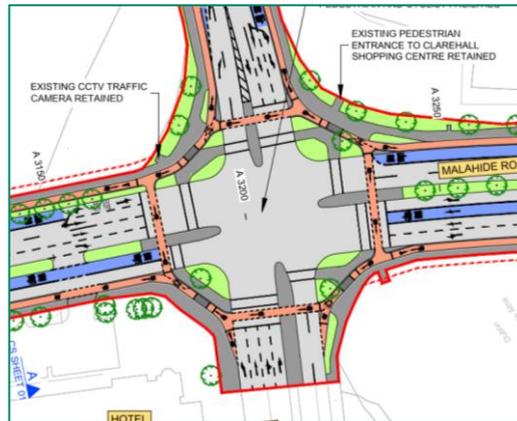
Figure 4.1 – Crossing Points along Malahide Road / R139 junction

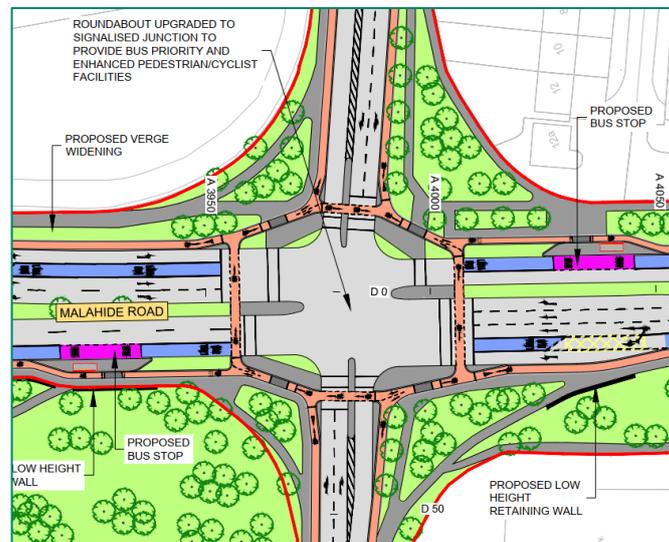
Figure 4.2 – Crossing Points along Malahide Road / Blunden Drive / Priorswood Road junction

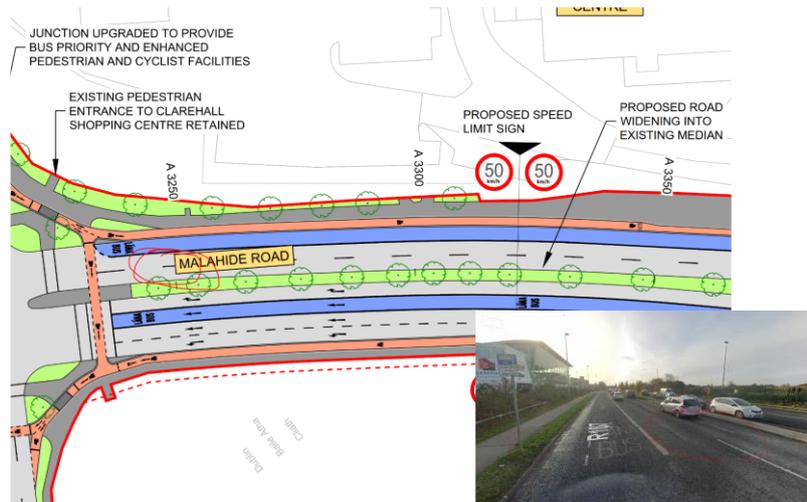
Figure 4.3 – Malahide Road Markings

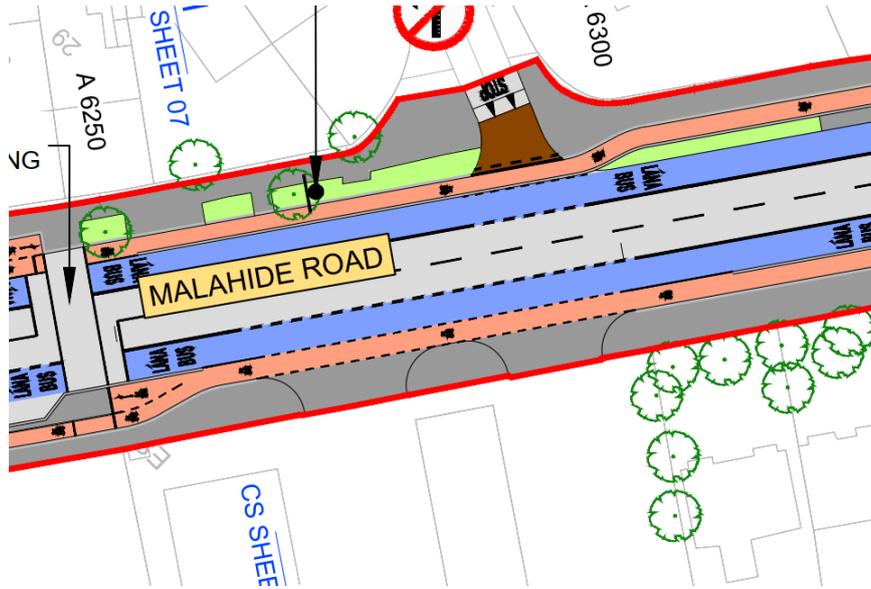
Figure 4.4 – Protected cycle lane across minor arm along Malahide Road

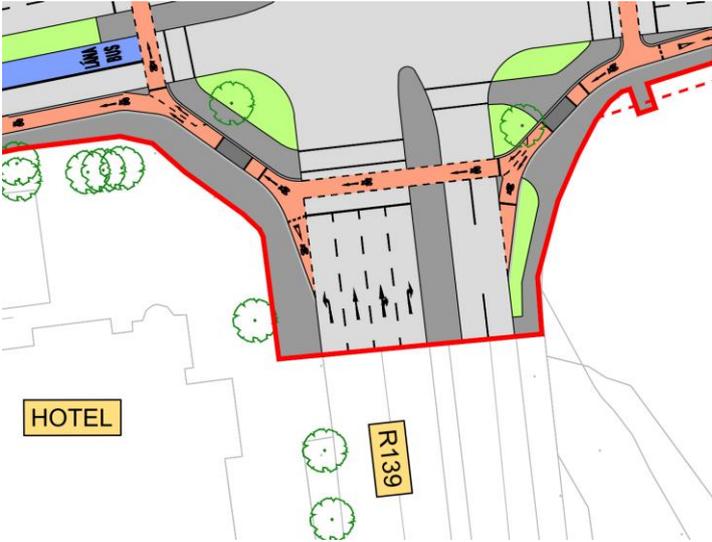
<p style="text-align: center;">Figure 4.5 – Start of Cycle Lane on R139</p>	
Description:	
<p>A cycle lane starts close to the junction, with the kerb line diverging from the main road carriageway at the left turn arrow. Some motorists may confuse this for a left slip lane, resulting in a vehicle colliding with a cyclist or pedestrian.</p>	
Recommendation:	
<p>Concrete kerbs or islands should be provided, with all necessary signage, to warn and prevent motorists from driving into the cycle lane.</p>

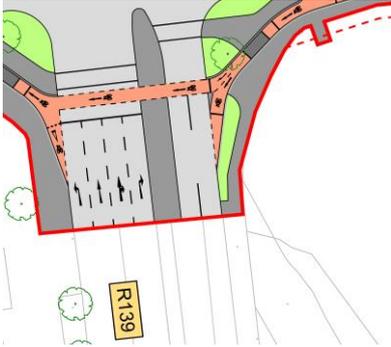
<p>Figure 4.6 – Exit of Cycle Lane on R139</p>
<i>Location:</i>	Clarehall Avenue Junction	
<i>Drawing:</i>	Sheet 06 of 21	
<i>Summary:</i>	Cycle signal staging	<p>INDICATIVE METHOD OF CONTROL</p>

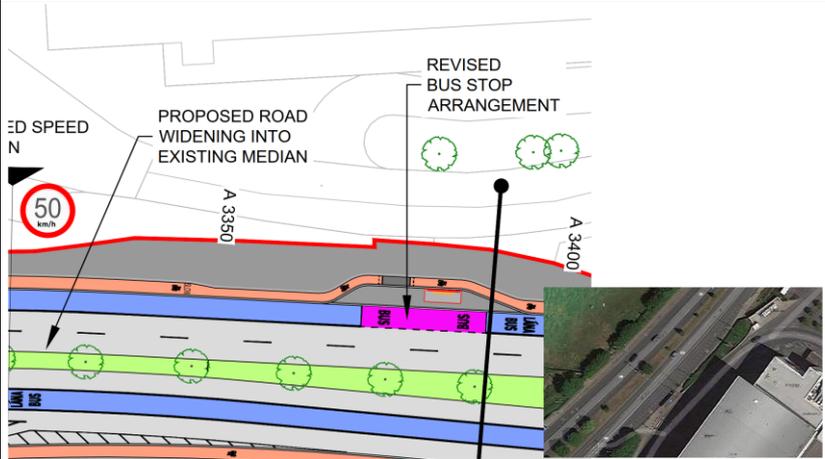
<p style="text-align: center;">Figure 4.8 – Bus Stop on the Malahide Road</p>
<p>The existing bus stop is approximately 40m long with currently 5 different route services using it. However, the proposed bus stop appears to facilitate only 1 bus . There is a risk that with a queue of buses, that some passengers will have to access or exit the bus at the cycle track, resulting in a collision with a cyclist. The shorter set-down area also presents a trip and fall hazard to pedestrians with the cycle lane.</p>	
Recommendation:	
<p>Ensure that the proposed bus stop length has sufficient capacity to cater for the expected number of buses during peak traffic periods.</p>

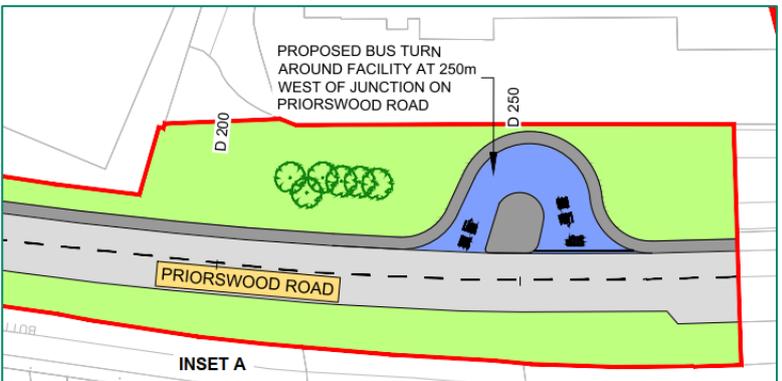
<p style="text-align: center;">Figure 4.9 – Priorswood Road bus turn facility</p>
<p>It is proposed to provide a bus turn facility along Priorswood Road. It is unclear if this bus turn facility is adequate to cater for buses turning in this area, if inadequate facilities are provided this could result in a bus over tracking the footpath and striking a pedestrian.</p>	
Recommendation:	
<p>The bus turn facility should be tracked to ensure that buses can turn in this area without infringing on the footpaths. Pedestrian crossings with raised crossing should be provided at the entrance and exit of the facility.</p>

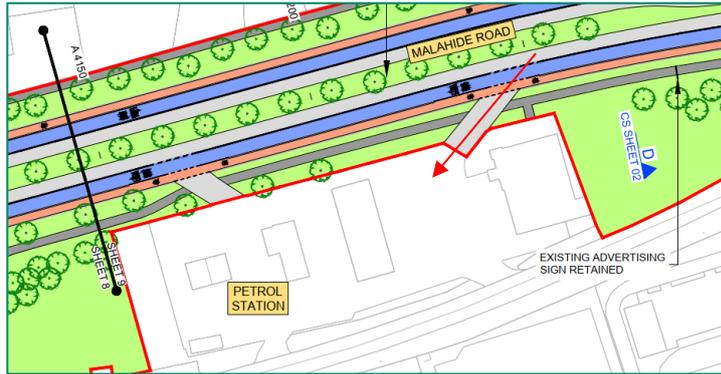
Figure 4.10 – Access to petrol station

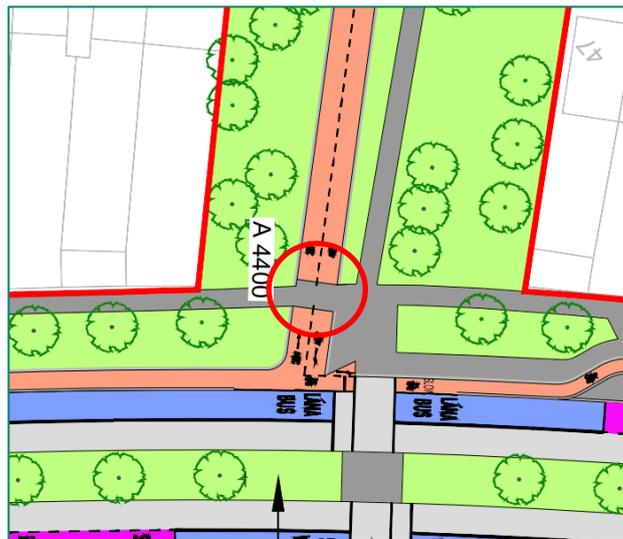
Figure 4.11 – Conflict point between footpath and cycle track

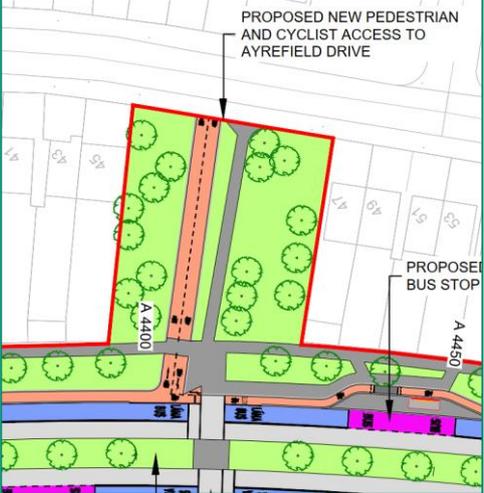
<p>Figure 4.12 – Proposed pedestrian and cyclist link</p>	
<p>The audit team are concerned that given the straight alignment of the new pedestrian avenue access to Ayrefield Drive, cyclists may not slow down. This could result in cyclists overshooting the cycle lane and travelling into the vehicle carriageway resulting in collisions with vehicles along the Malahide Road or striking a pedestrian crossing the cycle lane.</p>	
Recommendation:	
<p>Some form of preventative measure should be provided which reduces cyclists speed.</p>

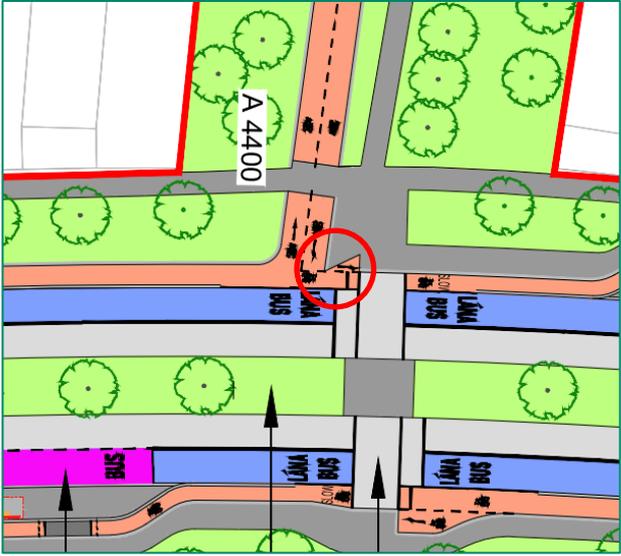
<p>Figure 4.13 – Proposed Jug Turn for cyclists</p>	
<p>It is proposed at the toucan crossings to provide a jug-turn for cyclists to access the crossing from the cycle lane. The jug-turn to be provided on the southbound approach along the Malahide Road at the Toucan Crossing is noted as having no apparent stacking capacity. This could result in cyclists using the jug turn forcing cyclists travelling southbound along Malahide Road into the bus lane which could result in a collision.</p>	
Recommendation:	
<p>The jug-turn at this location should be consistent with the jug-turn on the northbound approach, and provide enough stacking space for cyclists.</p>

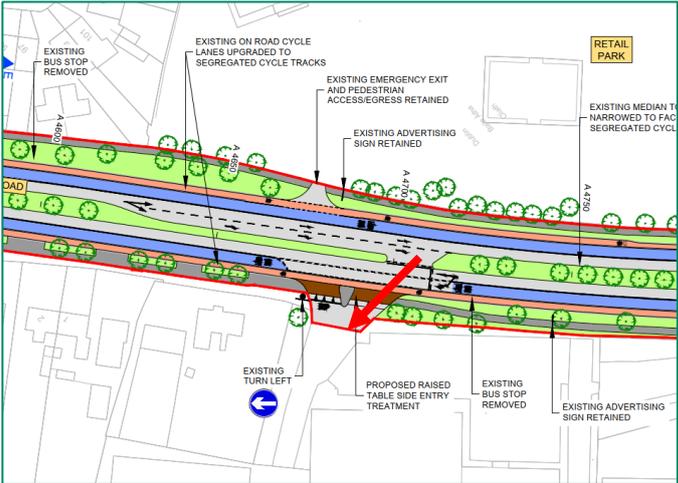
<p>Figure 4.14 – Right turn pocket</p>
<p>Large junction radii are currently provided at the access. This could result in instances where a vehicle cuts across the bus and cycle lane at speed resulting in a collision with a cyclist or bus. The audit team are also concerned that the right turn pocket provided for access into the Crown Decorating Centre along the Malahide Road is not situated in an adequate location for HGVs to turn into the site (red arrow).</p>	
Recommendation:	
The junction radii should be reduced to ensure that vehicle access speeds remain slow.

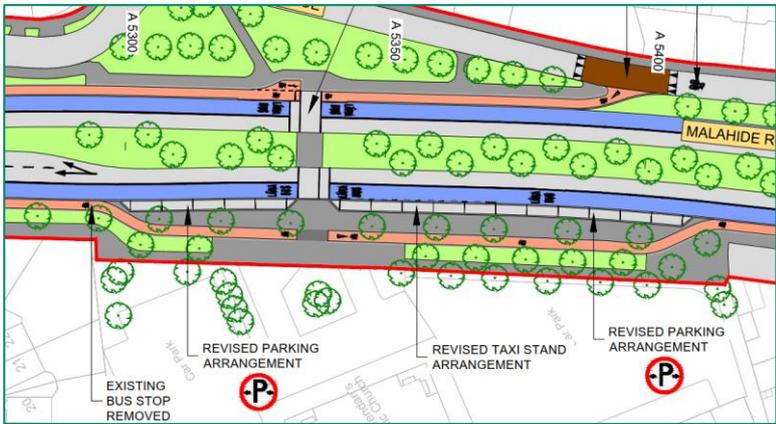
<p>Figure 4.15 – Proposed Parallel Car Parking Spaces</p>
<p>Parallel car parking spaces are to be provided on the Malahide Road (northbound) along the bus lanes without a buffer between the spaces and the vehicle carriageway. This could lead to instances where drivers do not check over their shoulder upon exiting their vehicles and results in them being struck by a bus, damage to their vehicle or buses swerving into the adjacent lane resulting in sideswipe and/or rear impact collisions.</p>	
Recommendation:	
A buffer should be provided between the bus lane and the parallel car parking spaces.

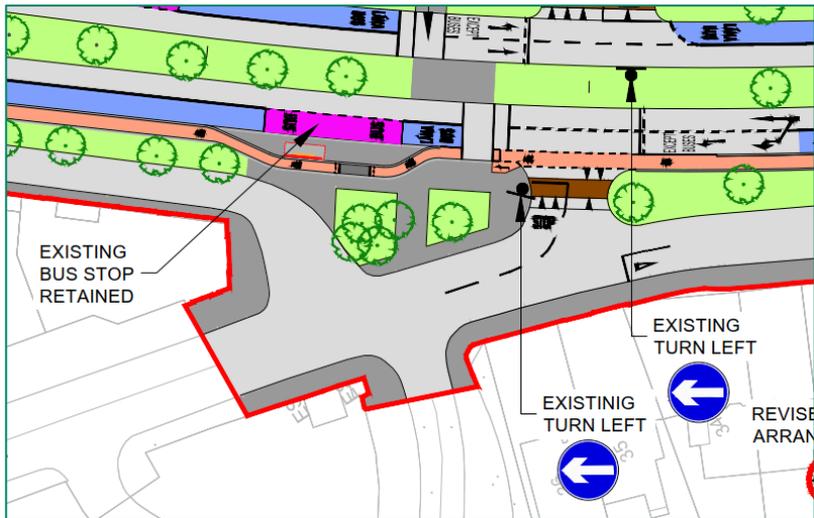
Figure 4.16 – Proposed Arrangement

4.3.11 Problem	
Location:	Coolock Village (Brookville Park Road)
Drawing:	Sheet 12 of 21
Summary:	Lack of pedestrian crossing locations
Description:	<p>The audit team note that there are no provisions for pedestrians to cross from the Malahide Road onto the Brookville Park Road. Lack of appropriate crossing locations can present a hazard to pedestrians, particularly vision and mobility impaired.</p>
Recommendation:	Appropriate crossing facilities should be provided at this location.

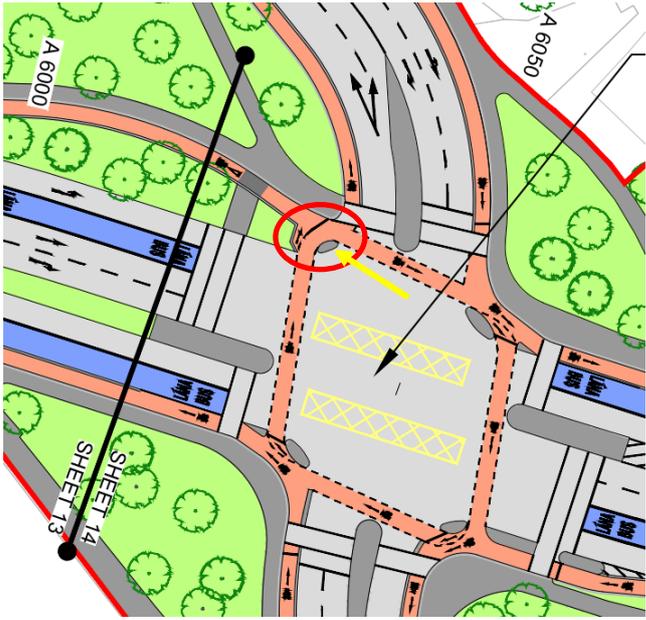
<p style="text-align: center;">Figure 4.19 – Right turn cyclist pockets</p>	
Description:	
<p>It is proposed that the Malahide Road / Gracefield Road / Ardlea Road roundabout is to be upgraded to a signalised 4-arm junction with protected cycle facilities. At the corners of the junction, a right turn pocket with a stop line is provided for cyclists but the north-eastern corner (circled red) has a different arrangement which could result in a cyclist not entering the right turn pocket and sitting at the concrete island (yellow arrow). Cyclists may not be aware of the intended arrangement which could result in cyclists attempting to cross during a traffic phase and being struck by a vehicle.</p>	
Recommendation:	
<p>The right turn cycle pocket at this location should be consistent with the other right turn cycle pockets at this junction.</p>

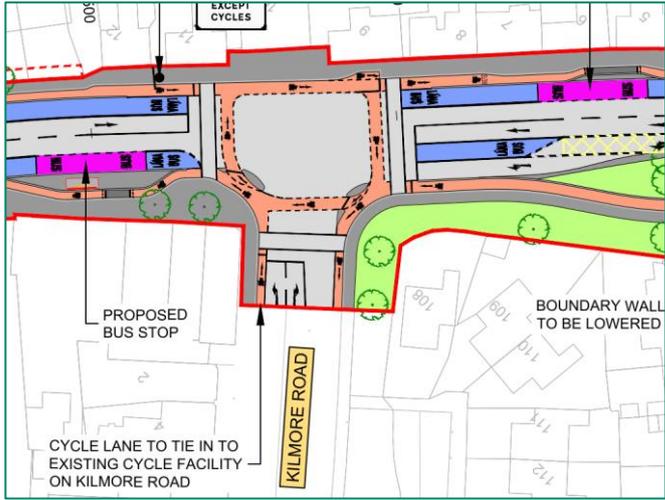
<p>Figure 4.21 – Malahide Road / Kilmore Road Junction</p>	
Description:	
<p>The cycle lanes provided along the Kilmore road on approach to / from this junction appear to be very narrow at this location on both sides of the carriageway. This could result in inadequate cycle lanes being provided which may lead to cyclist-vehicle collisions at this junction.</p>	
Recommendation:	
<p>Appropriately sized cycle lanes are to be provided at this location, in accordance with the National Cycle Manual.</p>

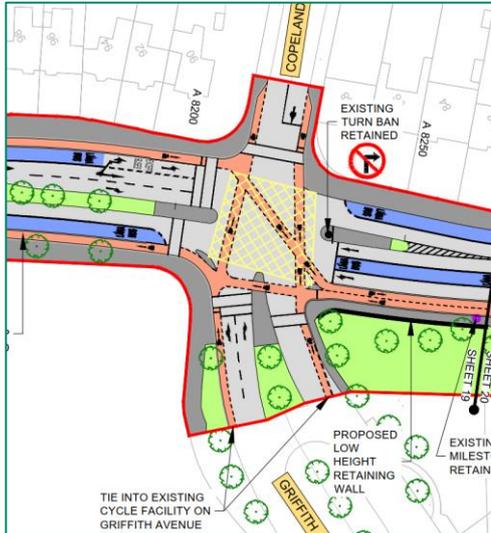
<p>Figure 4.22 – Malahide Road / Griffith Avenue Junction</p>	
Description:	
<p>The cycle lanes provided along the Griffith Avenue on both sides of the carriageway appears to narrow on approach to this junction. This could result in inadequate cycle lanes being provided which may lead to cyclist-vehicle collisions at this junction.</p>	
Recommendation:	
<p>Appropriately sized cycle lanes are to be provided at this location, in accordance with the National Cycle Manual.</p>

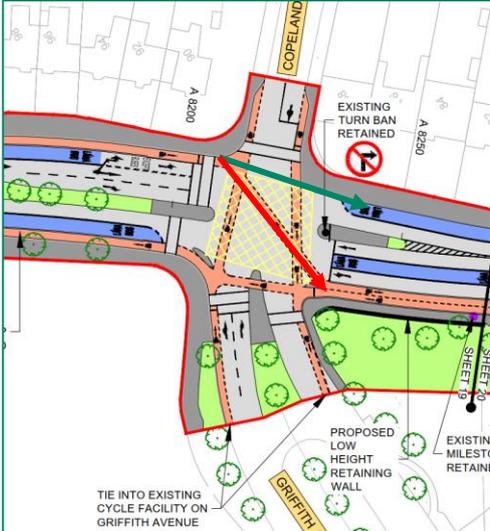
<p>Figure 4.23 – Malahide Road / Griffith Avenue Junction</p>
<p>For cyclists travelling southbound along Malahide Road they are directed across the Malahide Road / Griffith Avenue junction onto the new two way cycle track on the western side of the Malahide Road (red arrow). For cyclists that are more confident and familiar with the existing arrangement they are more likely to stay on road and continue straight through the junction and enter into the bus lane (green line). The audit team are concerned that cyclists will continue to remain on road and not utilise the proposed cycle track on the western side of the Malahide Road particularly if they wish to access any of the side streets off Malahide Road on the eastern side (Marino Avenue, Charlemont Road, Crescent Place, Marino Crescent).</p>

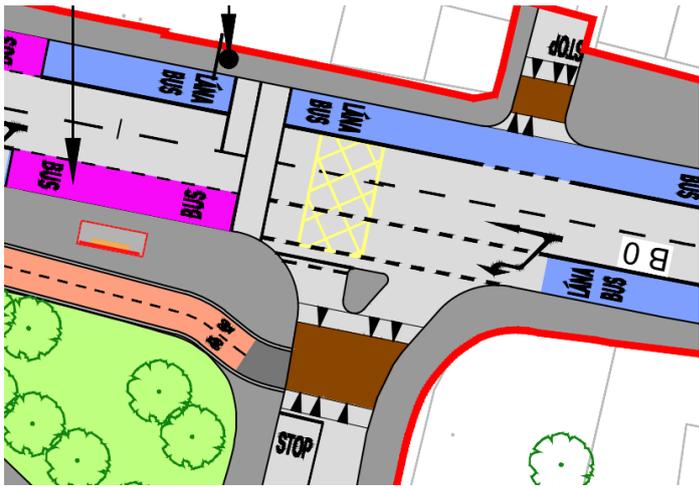
<p>The diagram shows a road junction with Malahide Road on the left and Brian Road on the right. Malahide Road has a bus lane (pink) and a general traffic lane (grey). Brian Road has a bus lane (blue) and a general traffic lane (grey). A pedestrian crossing is shown on Brian Road, with a yellow zebra crossing. A red line indicates the proposed pedestrian crossing location on the northern side of Brian Road. A 'STOP' sign is shown at the junction. A yellow dashed line indicates the current stop line for northbound traffic on Brian Road, which is located before the pedestrian crossing. A red dashed line indicates the proposed stop line for northbound traffic on Brian Road, which is located after the pedestrian crossing. The diagram highlights the lack of a stop line for northbound traffic at the proposed pedestrian crossing location.</p> <p>Figure 4.24 – Lack of Stop Line</p>

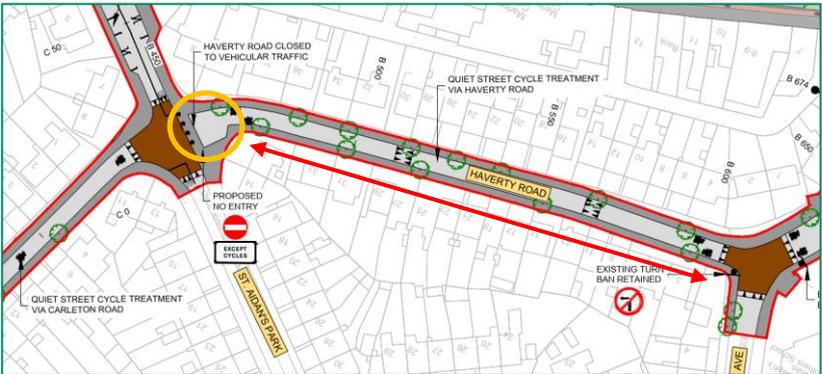
<p>The map shows the Haverty Road junction with St. Aidan's Park to the west and Marino Park Avenue to the east. Key features include: 'HAVERTY ROAD CLOSED TO VEHICULAR TRAFFIC' at the junction; 'PROPOSED NO ENTRY EXCEPT CYCLES' sign; 'QUIET STREET CYCLE TREATMENT VIA HAVERTY ROAD' and 'QUIET STREET CYCLE TREATMENT VIA CARLETON ROAD'; and 'EXISTING TURN BAN RETAINED' on Marino Park Avenue. A red arrow points to the Marino Park Avenue junction, indicating a potential reversal point for vehicles.</p>
Location:	Haverty Road / St. Aidan's Park

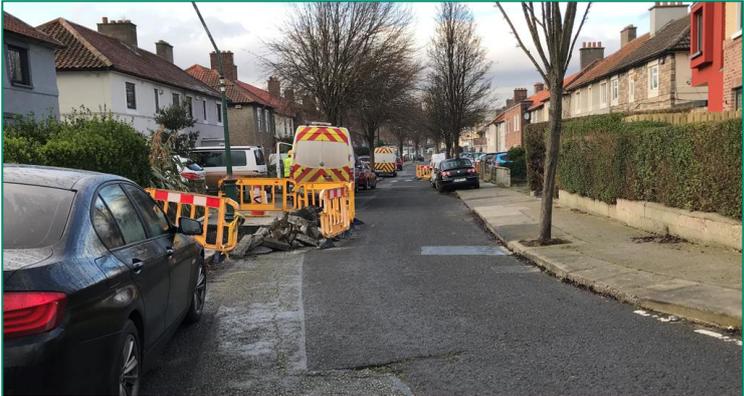
<p>The photograph shows a residential street with a dark car parked on the left. In the middle of the road, there are yellow and white construction barriers and a white van, indicating ongoing work or a restricted area.</p>
		<p>It is proposed that the Haverty Road arm of the St. Aidan's Park / Haverty Road junction is to be restricted to pedestrian and cyclist movements only and a turning head provided at this location to accommodate vehicles turning on Haverty Road. Should the turning head at this location be inadequate, this could result in vehicles having to reverse approximately 160m to the Marino Park Avenue junction (indicated by red arrow) which could result in a collision with a cyclist travelling northbound along Haverty Road.</p>
Recommendation:		
		<p>Autotracking should be undertaken to demonstrate that the turning head at this location is adequate to cater for large vehicle movements.</p>
